Integrated Fire Engineering and Response  
Malta meeting 10-11 April 2012

# Investigation report on a wooden furniture industry fire.

Tsatsoulas Dimitrios

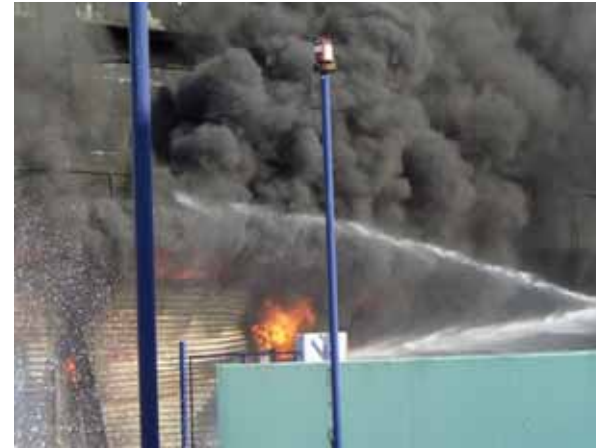
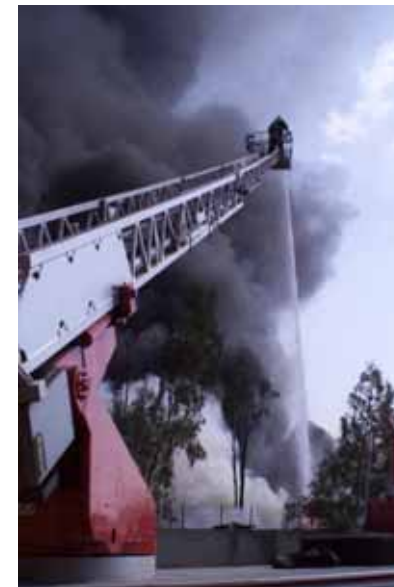
- The initial call reporting this incident was at 13.06 hours i.e in the middle of working day.
- Timber complex had a trained and equipped Emergency Response Team (ERT) that included 30 members. On the day of the incident; 15 trained emergency responders were immediately available.
- Firefighters from the surrounding fire stations were in 'emergency alert' providing 27 fire vehicles with 80 fire fighters deployed at the scene of fire.
- Fire extinguished after ten (10) hours.

1. That the fire has been caused by sparks during maintenance activities(hot works) in the machinery area.
2. No special fire precautions during 'hot works' has been taken as predicted by government decision 7/1996
3. Fire was not contained to the room of origin and spread to the whole building
4. Fire almost immediately spread from first to second ignited materials.
5. Fire Compartments were inadequate to stop the fire, and fire was no possible to be suppressed by permanent fire fighting hose reels by industrial fire staff.

- Almost the whole wooden material and electro-mechanical equipment of industry have been destroyed by the fire.
- Estimated property loss 1.600.000 euro.
- On the other hand, the reinforced concrete, columns, beams performed very well in such a severe fire due to high fire resistance of reinforced concrete.
- Nine(9) workers and one(1) fire fighter have been transferred to the local hospital suffering from scrapes and smoke inhalation.

- Proper use and application of fire safety measures needed
- Check the company's space ; It must be always cleaned from dust and wooden shavings
- Keep out the flammable substances and sparks and take the necessary fire precaution where is required

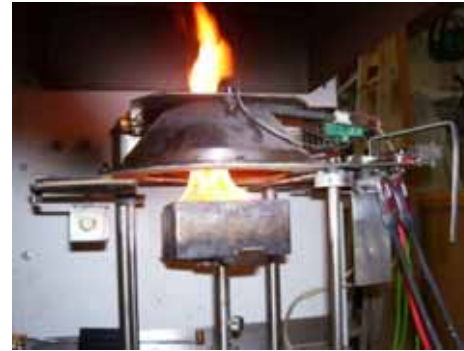
- All untreated samples clearly burned faster and with the highest HRR.

Pine exposed at Heat flux 35kW/m<sup>2</sup>

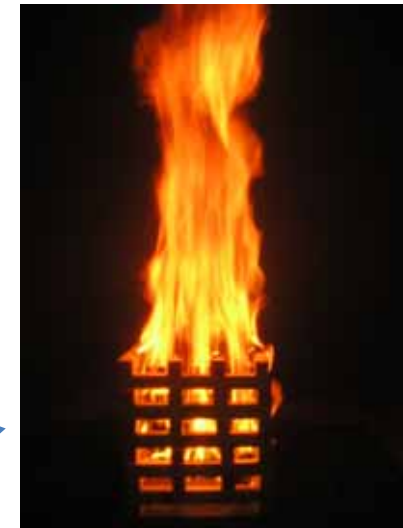
Untreated pine crib into the test.

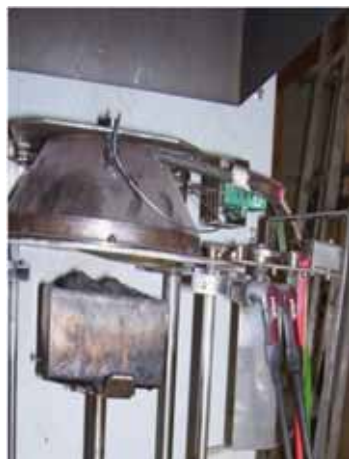
No ignition' and lower toxic emissions compared to untreated samples were observed at 35kW/m<sup>2</sup> (small scale).

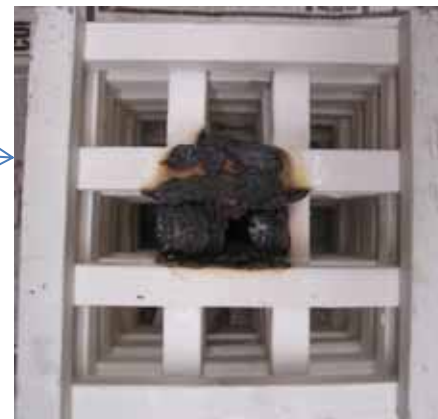
- In all fully-treated (100%) cases, there was no ignition, and increasing amounts of ethanol, i.e., 6, 20, and 30g, were used as ignition sources.
- A “weak” flame initially developed from the burning of ethanol, which “triggered” the in-tumescent flame retardant paint to expand and form “instant firewalls” to contain and finally suppress the developing fire.

**100% treated pine crib  
(used 20g of ethanol as ignition source)  
in the end of experimental process.**
