## Integrated Fire Engineering and Response

## *Protection of historical buildings against catastrophic actions: case studies*

*PhD Student: Roberta Fonti*

*University of Naples "Federico II"*

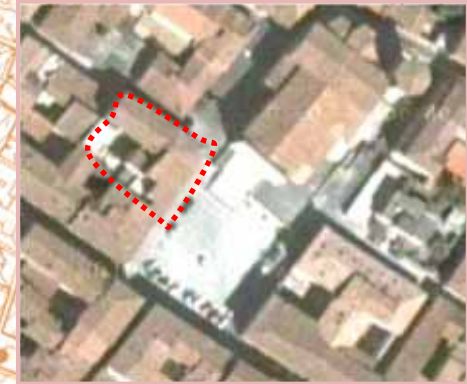
OLD Palace after seismic event - corner failure -

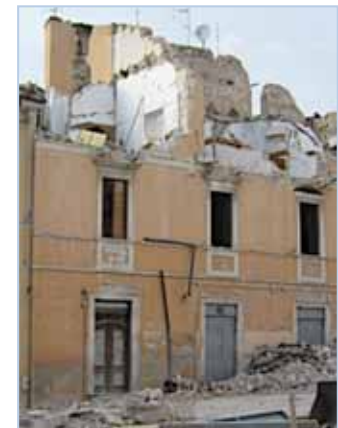
Defects detected

- 1) NO transversal connections
- 2) NO contact between stones – mortar joints too bigger

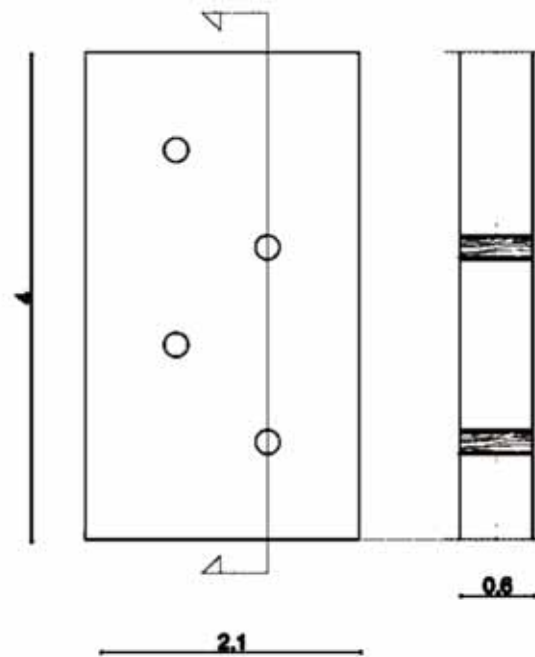
## PANEL 5 REINFORCEMENT STRATEGY

no transversal section links

thick mortar joints and consequently no contact between stones

Headers in wooden pushed in load condition by wedges

Replacement of the mortar joints with small bricks elements formed like wedges.

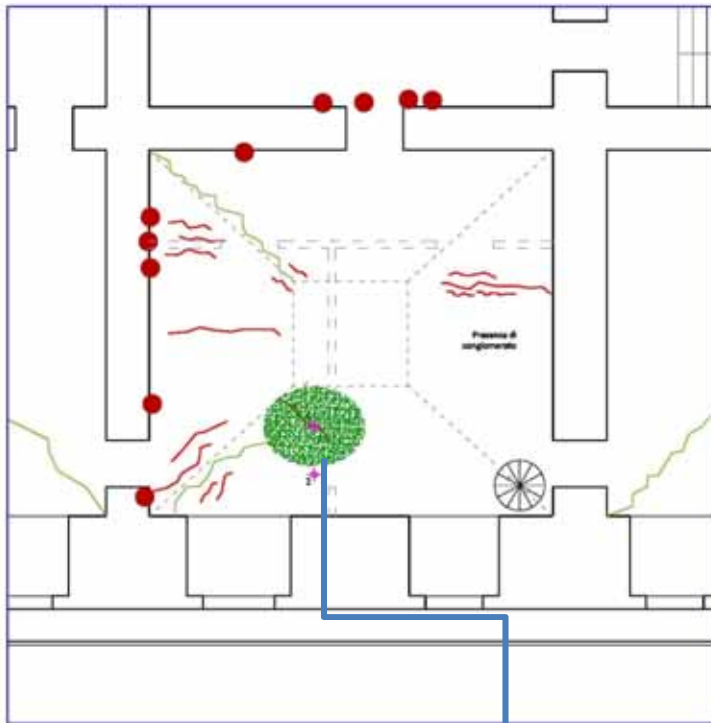
Area bombed during World War Two

break due to the bomb impact

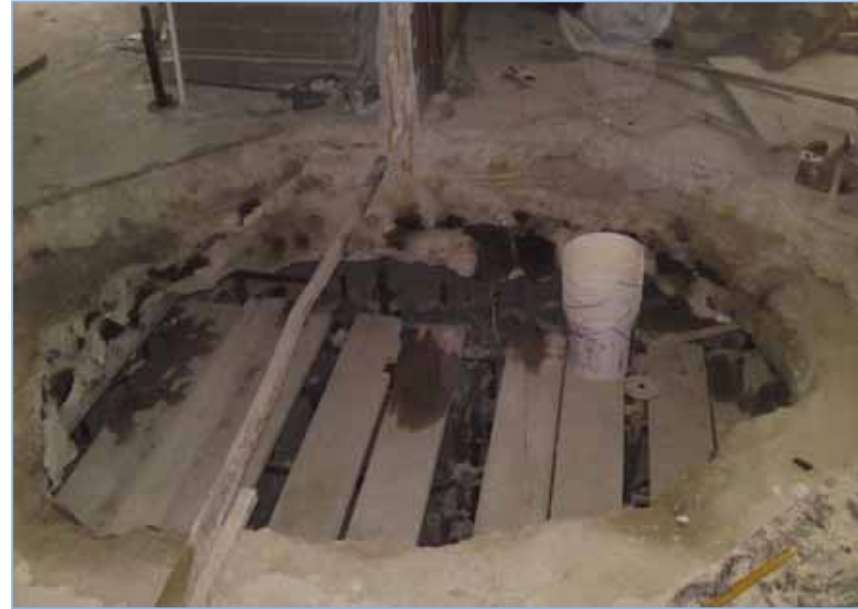
Damage occurred in 2009. it was due to wrong reinforcement intervention

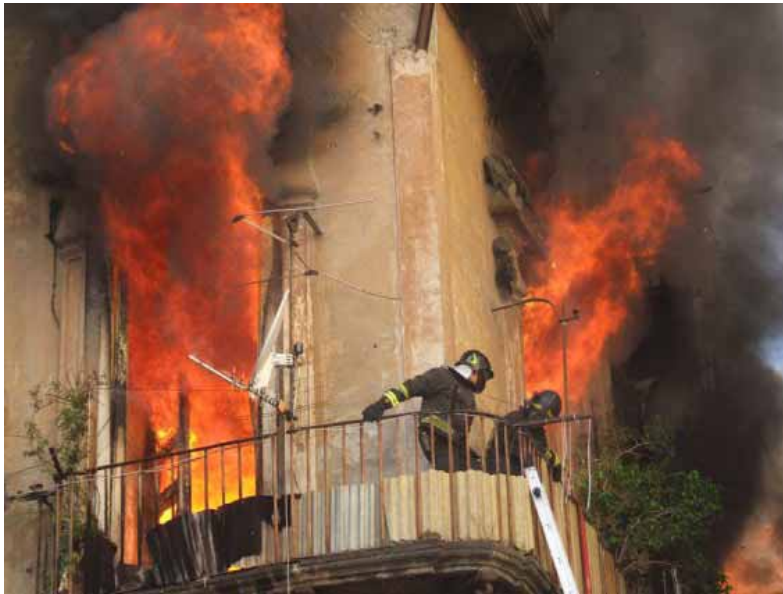
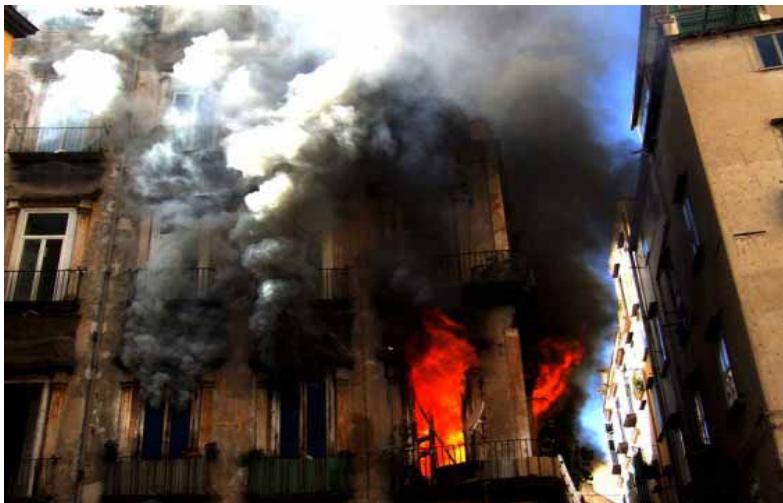
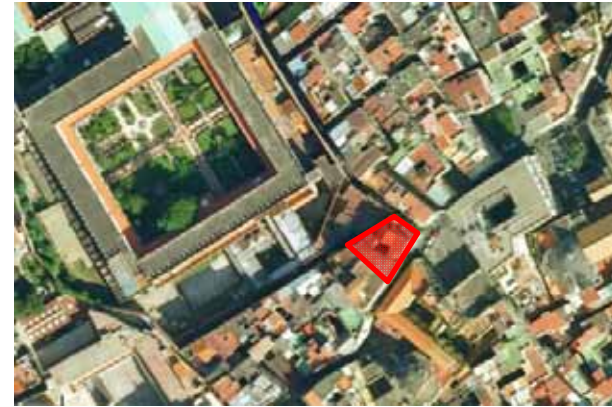
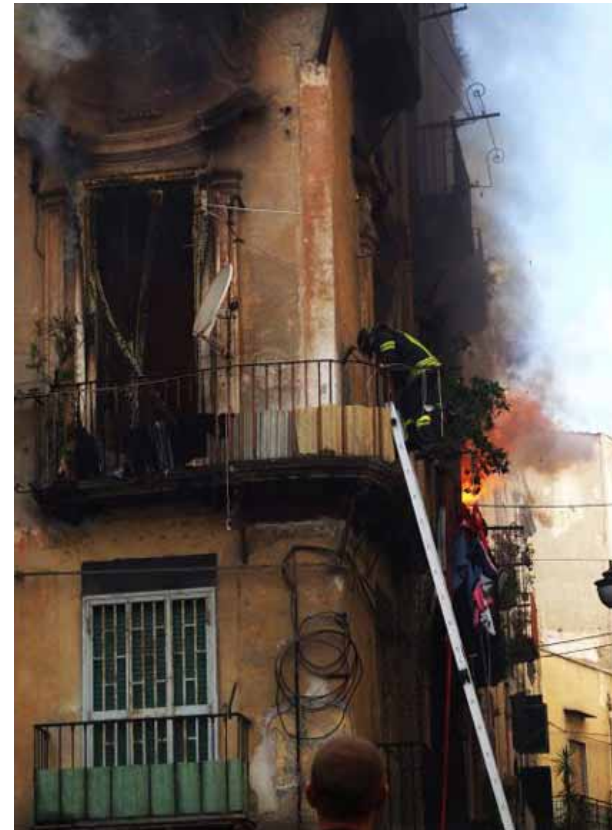
The Marquees Vernasse of Akaia palace, Naples  
FIRE ACTION – OCTOBER 2009

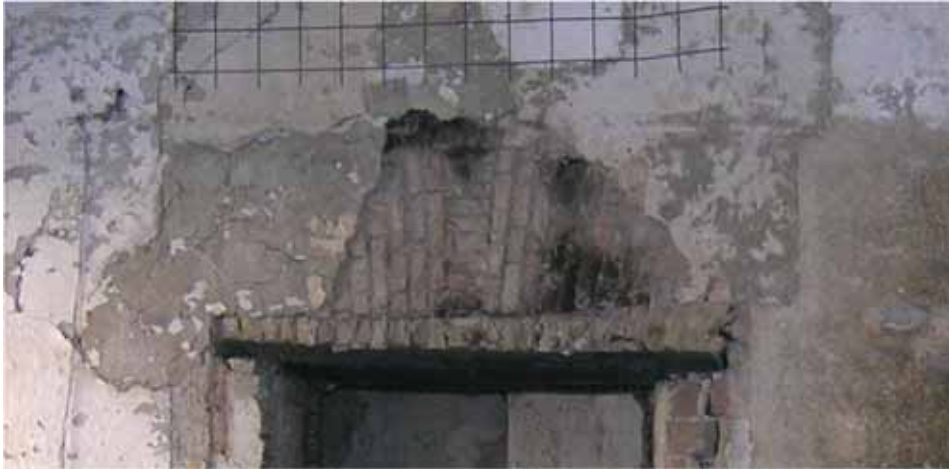
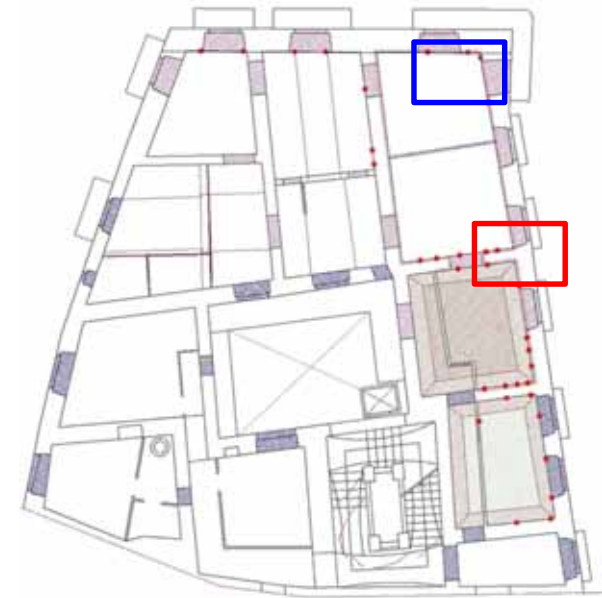
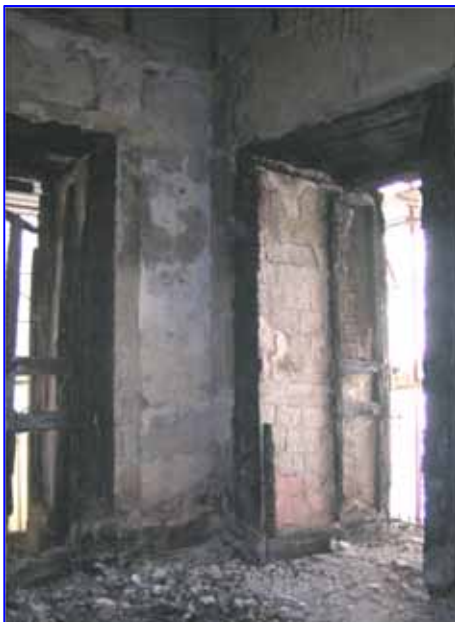
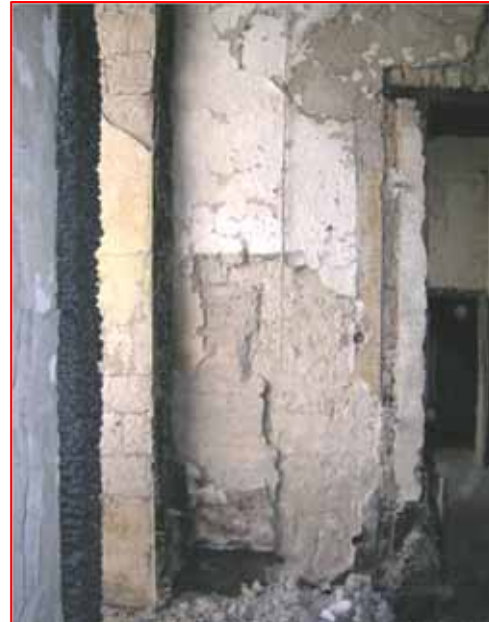
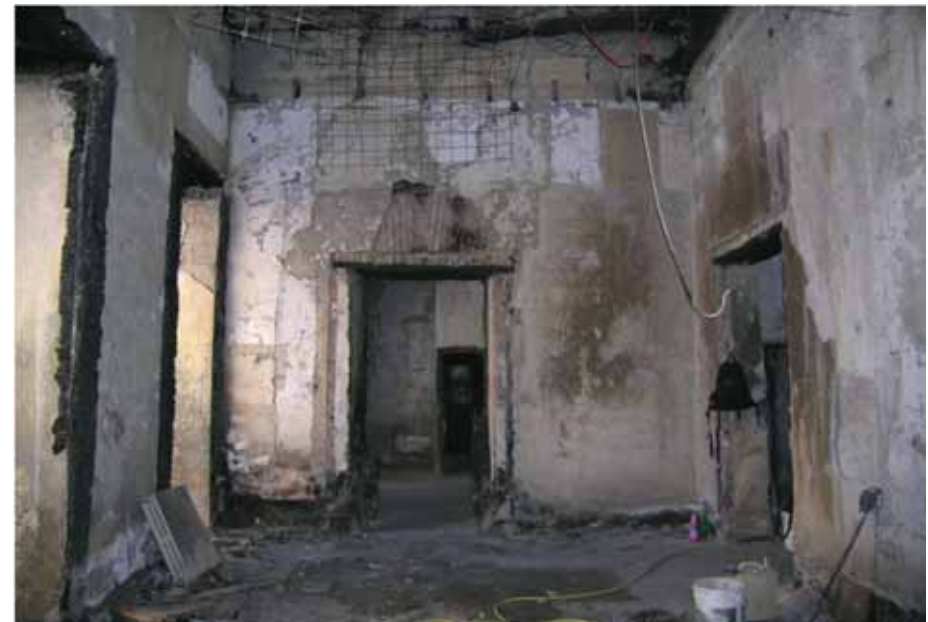
The Marquees Vernasse of Akaia palace, Naples  
FIRST FLOOR DAMAGE OCCURRED

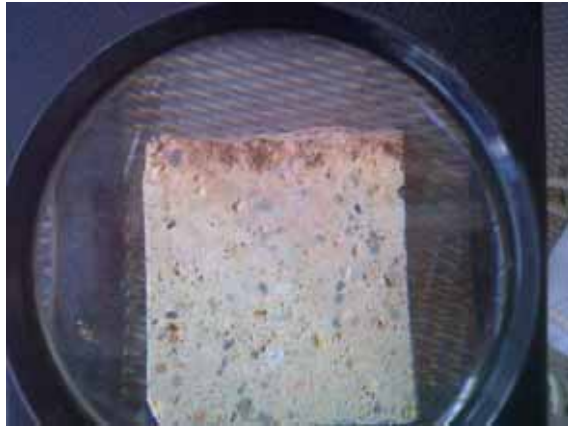
Thickness degraded - 2,70cm

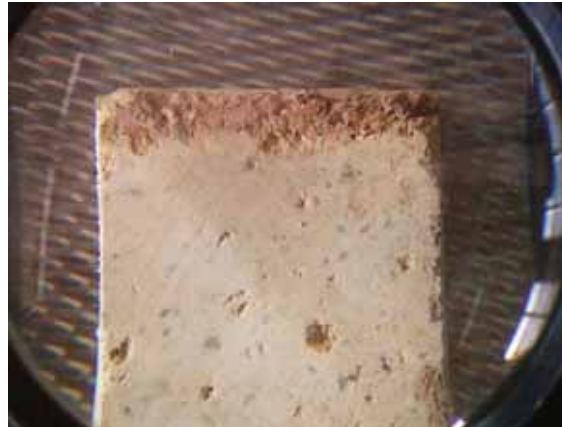
Thickness degraded - 2,95cm

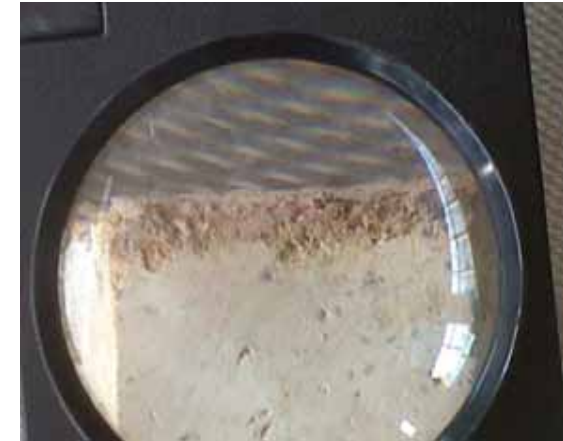
Thickness degraded - 2,66cm

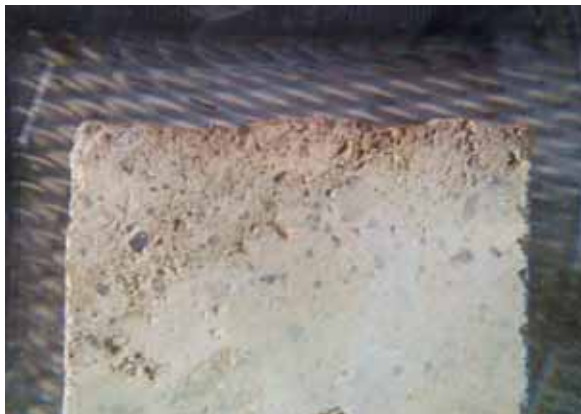
Thickness degraded - 3,56cm

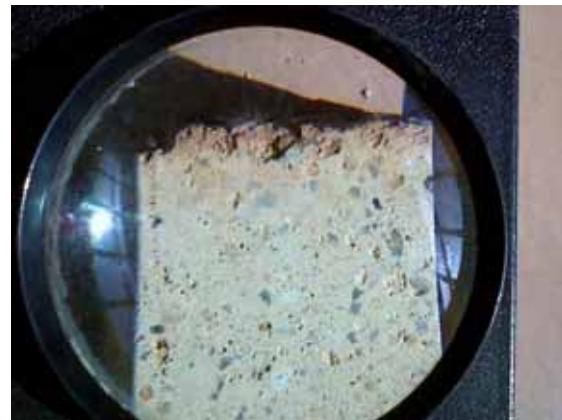
Thickness degraded - 4,11cm

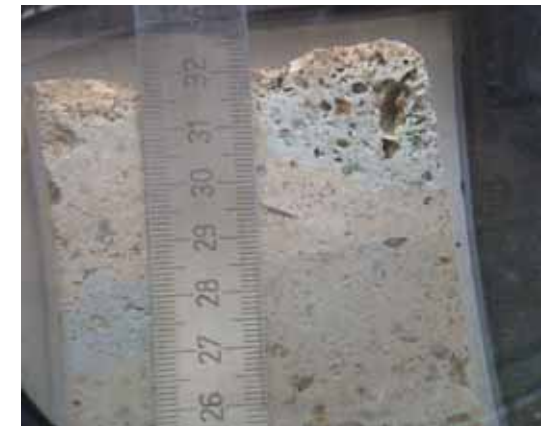
Thickness degraded - 3,60cm
