Fire Brigade Reports and Investigations in Italy: Procedures and Statistics

Fire Brigade Reports and Investigations in Italy: Description of Real Fires

A real investigative asset

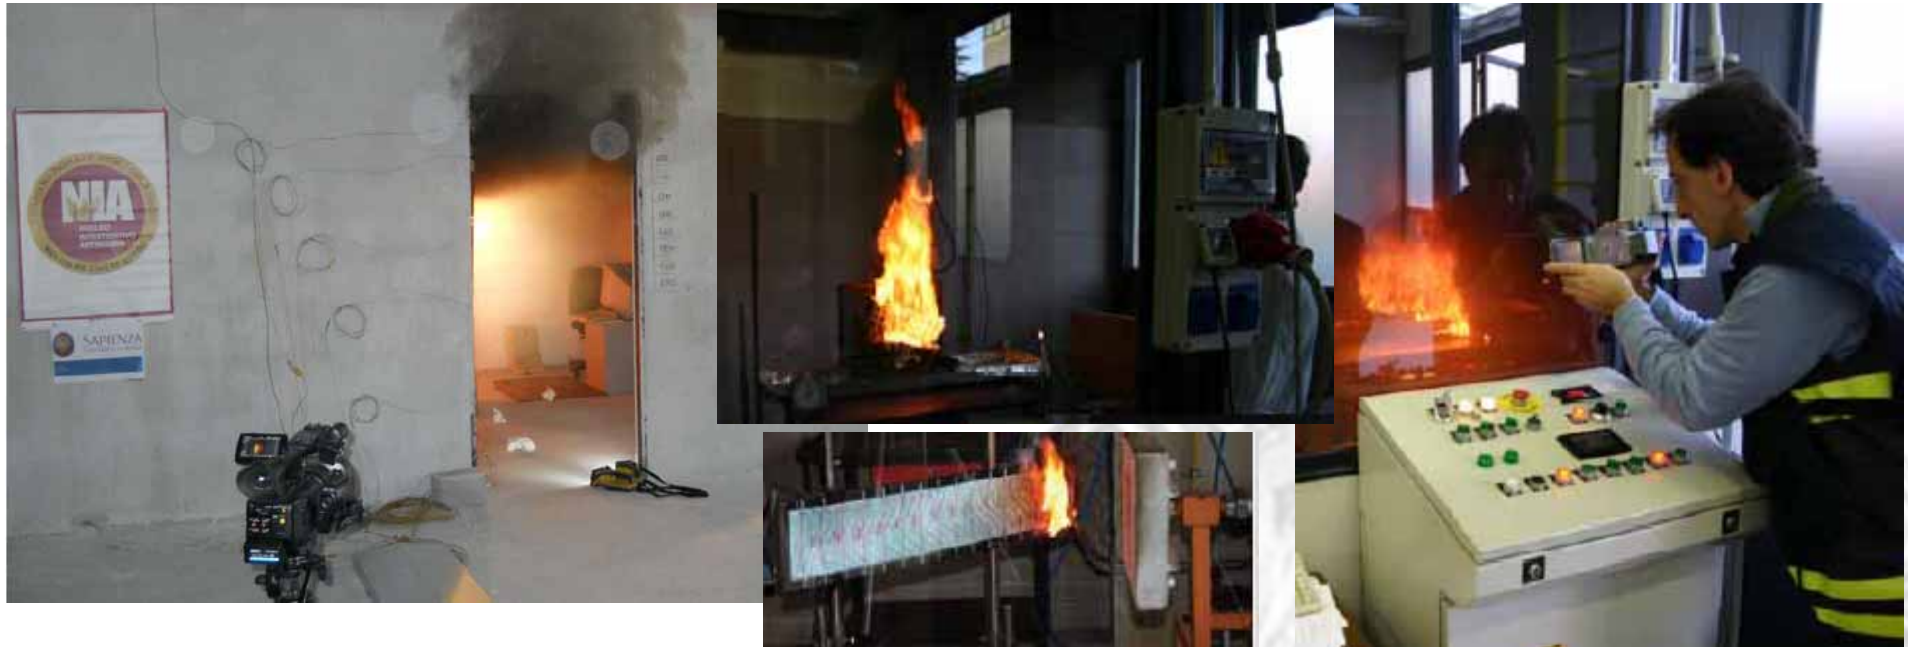
The NIA has a test-laboratory located in the area of the Operational Training School of Montelibretti (Rome, Italy), where fire simulations on full-scale and fire scenarios are carried out.

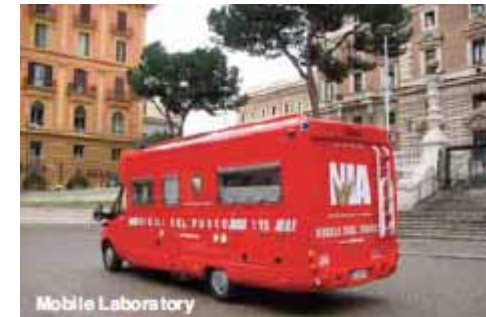
The intervention vehicle used by the NIA is a mobile laboratory, a camper specifically equipped with systems for the environmental monitoring operations, for detecting flammable substances, for producing evidence, and for judicial attachment. It allows also to take immediately minutes of the Fire investigation procedures followed in the intervention and to produce the documents of the conducted Investigation.

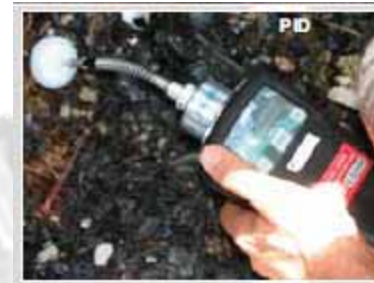
The PID (Photo Ionization Detector) is used to detect vapours of volatile organic compounds. Inflammable liquids are among the substances the PID can detect.

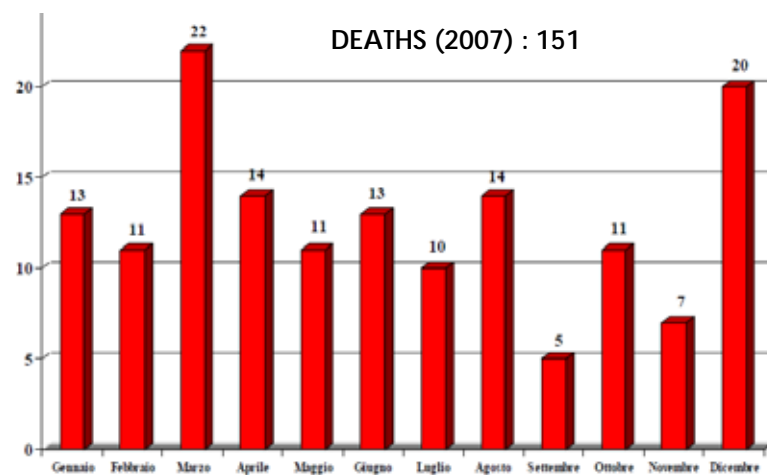
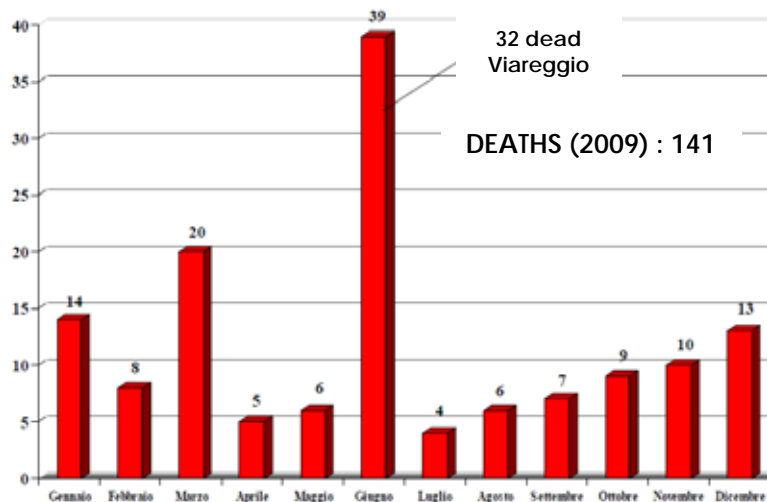
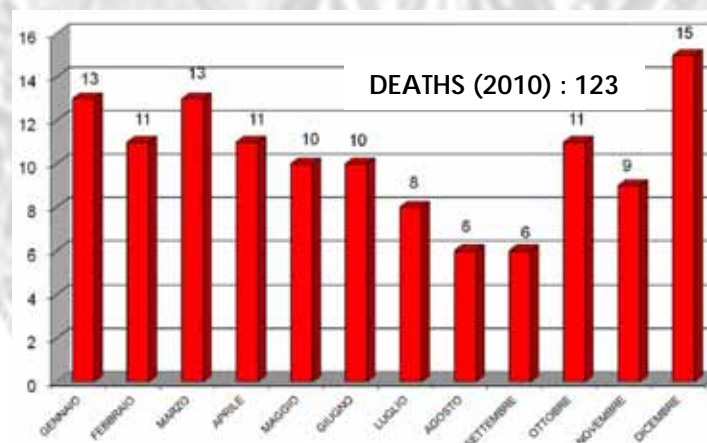
Death's distribution by months

A research has examined all the reports received by the National Operations Centre of the Ministry of the Interior, relating to fires and explosions occurred in Italy, in the time period between 2007 and 2010. The research gives information about deaths in consequence of fires and explosions, providing useful data not only for accident prevention, but also for the organizational management of the rescue of the National Fire Brigade.

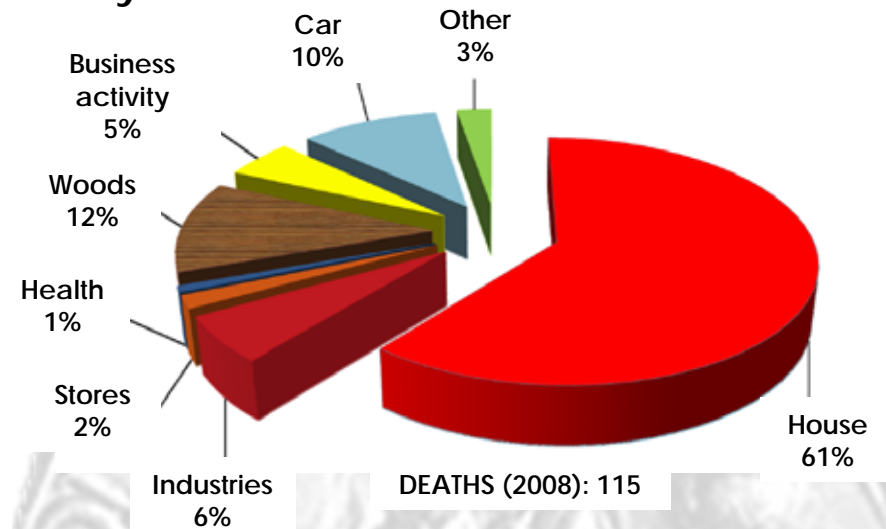
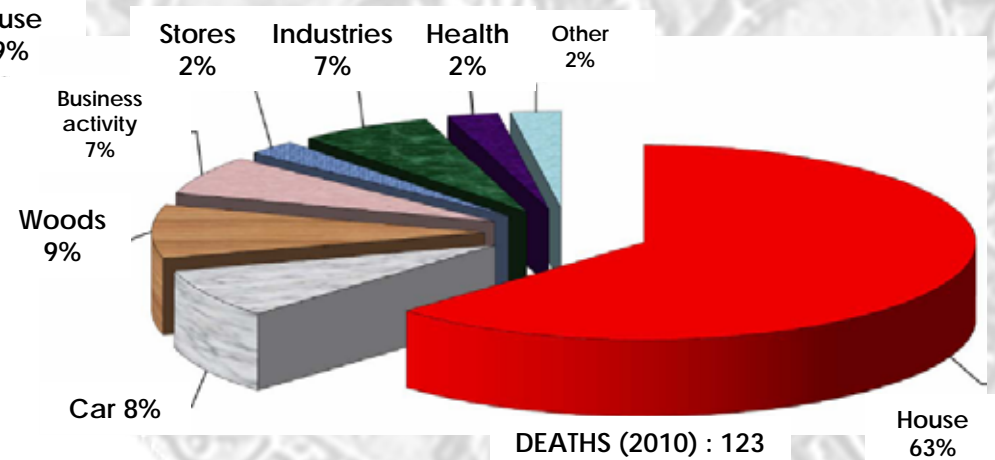
Death's distribution by activities

A research has examined all the reports received by the National Operations Centre of the Ministry of the Interior, relating to fires and explosions occurred in Italy, in the time period between 2007 and 2010. The research gives information about deaths in consequence of fires and explosions, providing useful data not only for accident prevention, but also for the organizational management of the rescue of the National Fire Brigade.

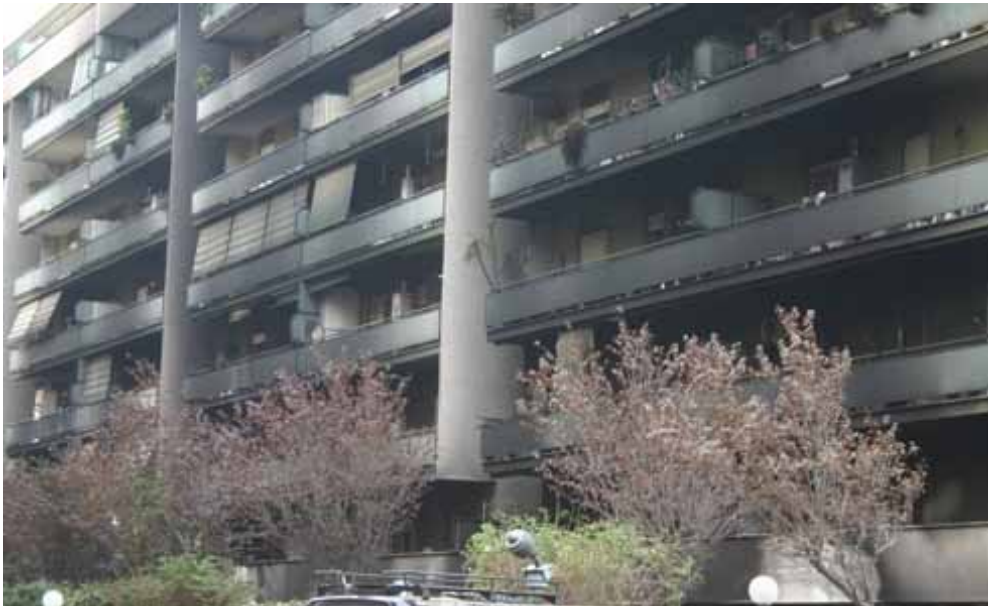
In 2008: fire of cars parked in a residential building.
Building's description:
✓ total length: 120 m;
✓ height: 27 m;
✓ 8 floors above ground.

Fire involved 39 cars and 17 motorcycles.

The fire caused the rupture of water, gas and electrical systems.

The fire caused the evacuation of the building.

REQUIREMENTS: it is necessary that the material, used as a coating in buildings, is protected from the fire. As recommended from EUMEPS, the protection can be realized with a layer of plaster thickness of 9-10 mm minimum, because it was shown that this is sufficient to reduce the possibility of ignition, provided that the coating layer is mechanically anchored.

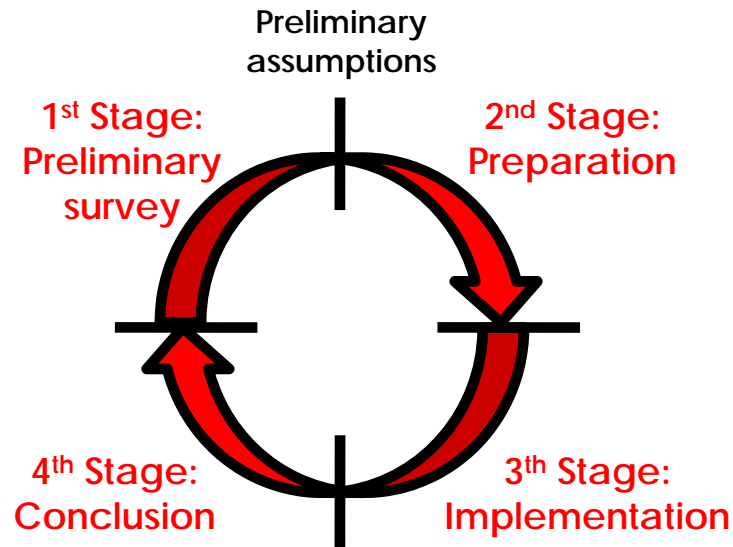
A real investigative asset: 1st Stage

Evidence collection: based on first evidence, fire is started from a car;

Analysis of reports of first rescuers: fire has reached the flash-over in the ground floor;

Analysis of video produced: a video, posted on line, confirms the assumption about the flash-over and permits the calculation of time in which the flash-over has reached (20-25 min, with a spread of 12-8 cm/s);

Analysis of fire's report with the same characteristics: it easily allows to express *temporary assumptions* about the causes of fire.

- ✓ *Fire could be ignited due to failure of car's electrical equipment or use of open flames or use of liquid fuel.*
- ✓ *Based on the analysis of fire developed in a building with the same characteristics, flash-over could be reached due to dripping of the polystyrene used for the insulation of the ceiling*

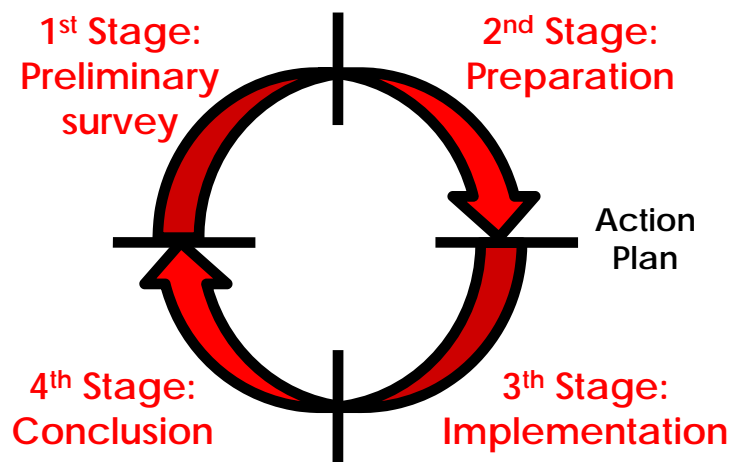
A real investigative asset: 2nd Stage

- ✓ Need for checking: a) the presence of liquid fuel (substances that accelerate the fire's development as petrol) and solid fuel (substances able to ignite fire); b) failure of car's electric equipment;
- ✓ Need for checking the assumption about the dripping of polystyrene and its ability to spread the fire to the other vehicle.

- ✓ *inspection aimed to verify:
the presence of liquid fuel, by using P.I.D.;
the presence of solid fuel;*
- ✓ *inspection of car from which fire started;*
- ✓ *fire reaction test of polystyrene in accordance with "UNI-CNVVF 9174".*

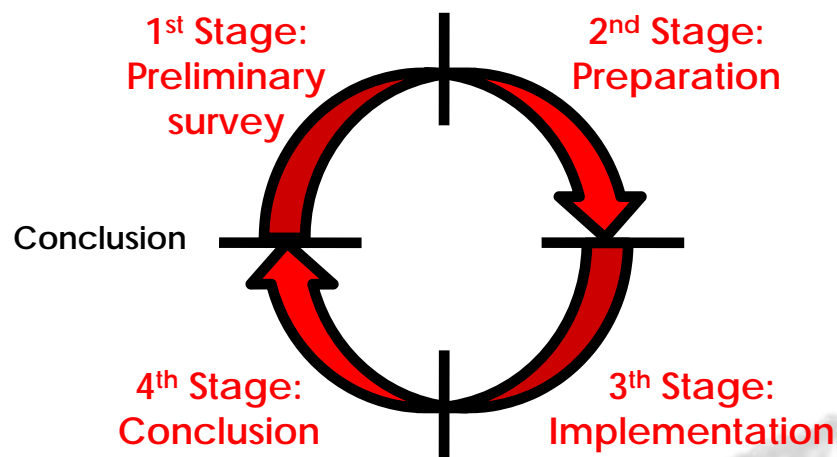
A real investigative asset: 4th Stage

- ✓ The P.I.D. didn't detect the presence of liquid fuel, even near the tanks; therefore the result isn't reliable because all the fuel is burned;
- ✓ The presence of solid fuel wasn't detected;
- ✓ The car from which fire started was completely destroyed; therefore it isn't possible to verify the electrical failure;
- ✓ The small portion of tested polystyrene was able to ignite a tire of car following the dripping; therefore it is reliable that in situ other cars were involved in fire due the dripping of large size of material.
