# The problem of robustness in fire

**Ian Burgess**

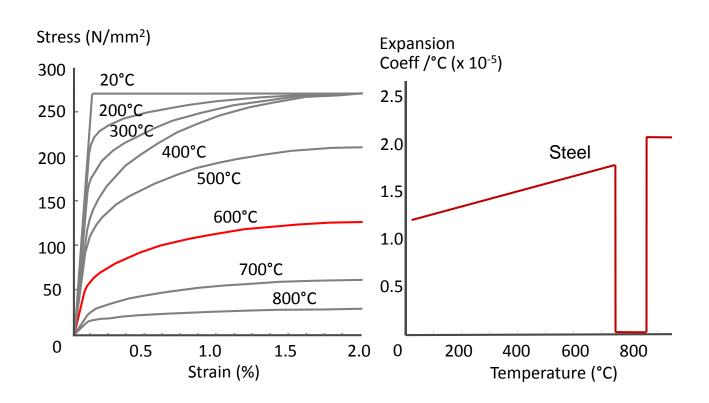
#### Steel behaviour at high temperatures

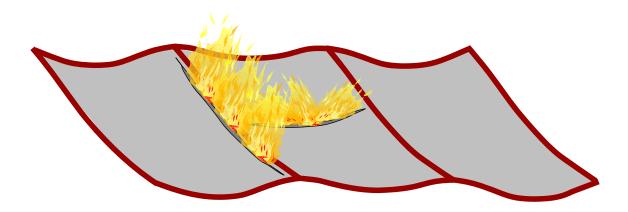
## Consequence of excessive beam deformation

**Beam/slab** deflection does not in itself cause structural failure, unless it causes columns to buckle or joints to fracture.

It may cause compartmentation integrity failure which allows fire to spread.

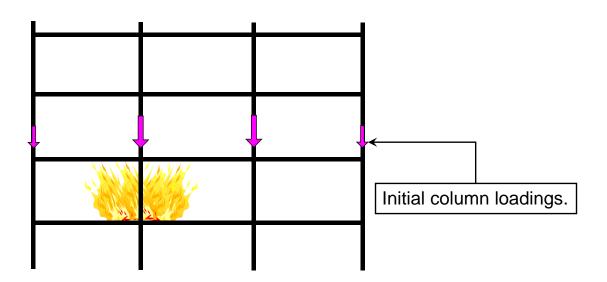
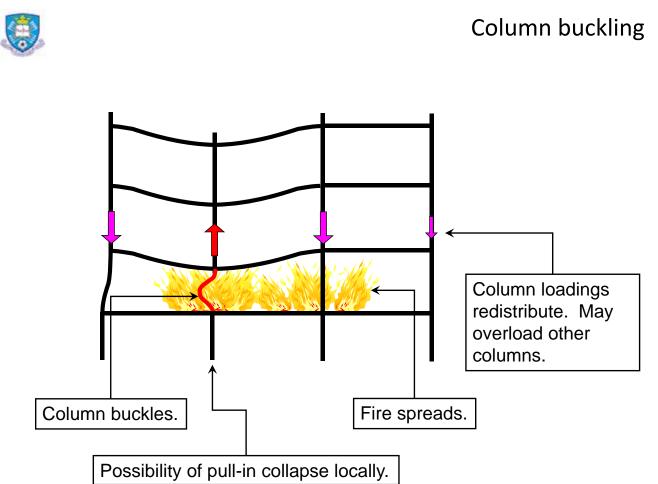
# **Column buckling**

- Loads are redistributed to adjacent columns similar to "column-out" scenario in blast-resistant design.
- A single column collapse may lead to severe local collapse.
- May be mitigated to some extent by 2-dimensional redistribution via slabs.
- If these are also affected by temperature-dependent strength reduction there is a high probability of building collapse.
- Columns should be designed for fire resistance with care. Passive protection is usually required.

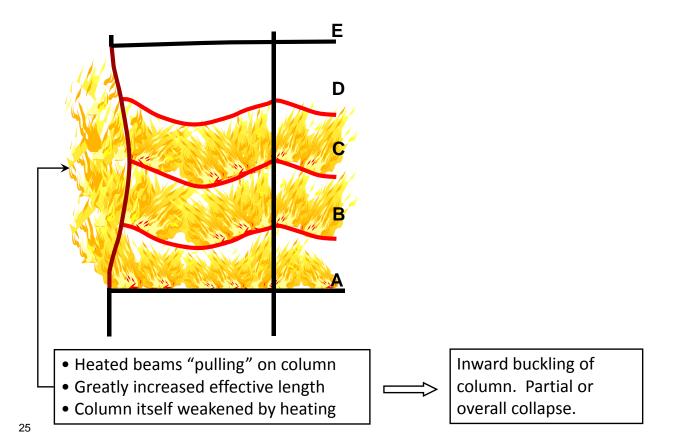
#### Pull-in-enhanced buckling of columns

WTC 1 exterior columns bowing inward across most of the south face between floors 95 to 98 at 10.23 am.

Perimeter wall analysis found "... an inward pull force of 27kN at each column at floors 95 to 99, starting 80 minutes after the aircraft impact, caused a maximum inward bowing of 790mm."

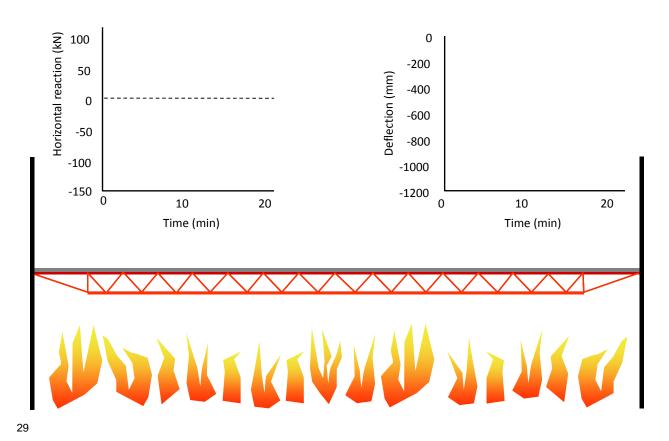
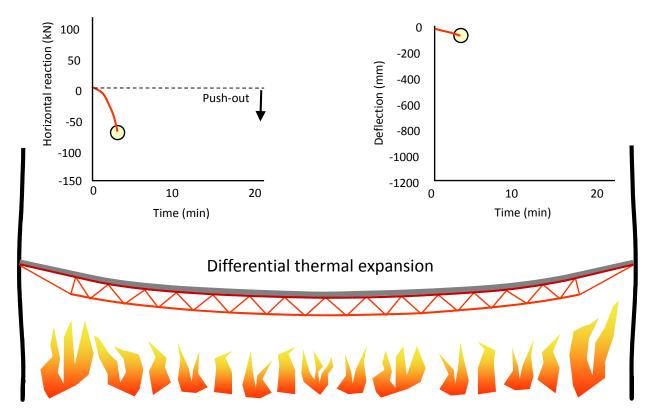
# **Catenary forces on connections**

WTC 1 and 2 floor trusses

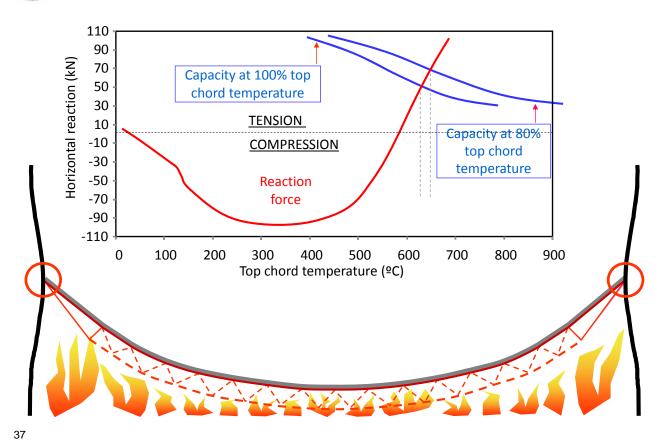
#### Tying forces on connections

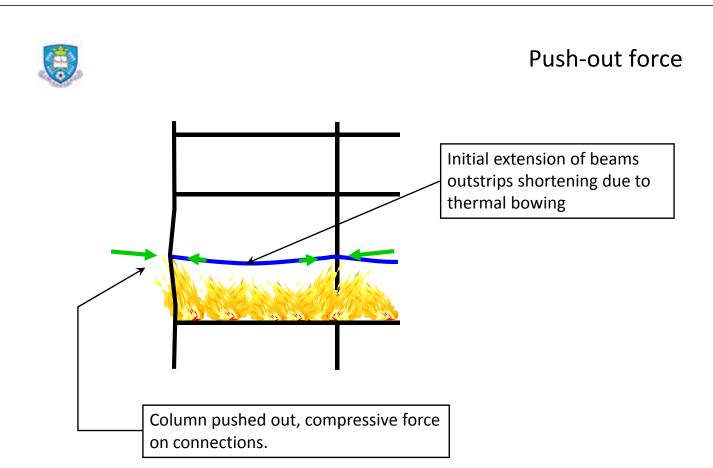
#### Generation of connection failure

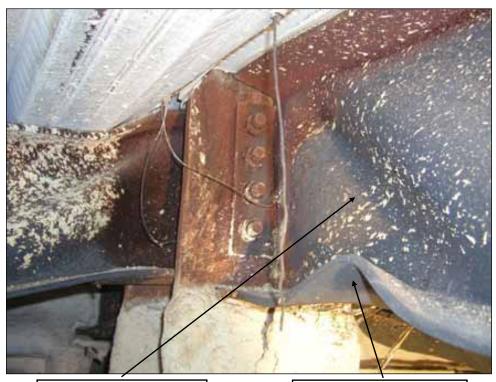
# Cardington Beam-Column Joint Fire Test 7

Beam shear buckling

Beam flange buckling

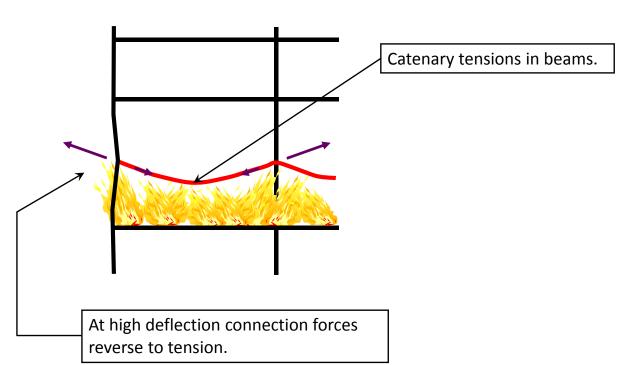
# Connection tying force

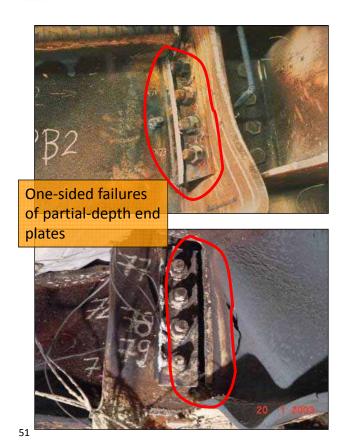
#### Joint failures in cooling

- One-sided failure of partial-depth end plates during cooling phase.
- Reduced stiffness retains joint integrity.
- Partial fracture may happen when cooling from net compression ...

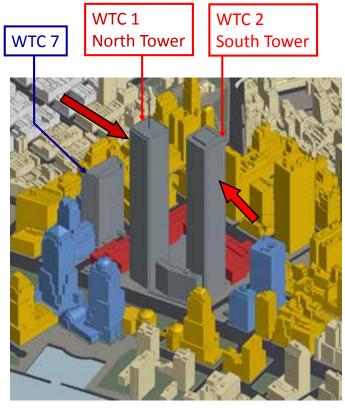
## Sequence of events on September 11, 2001

Time	Event
08:46	WTC 1 Impact ~92 <sup>nd</sup> floor Boeing 767-200, 750 km/h
09:03	WTC 2 Impact ~78 <sup>th</sup> floor Boeing 767-200, 945 km/h
09:59 \	WTC 2 Collapse
10:28	WTC 1 Collapse; other building impacts
17:20	WTC 7 Collapse

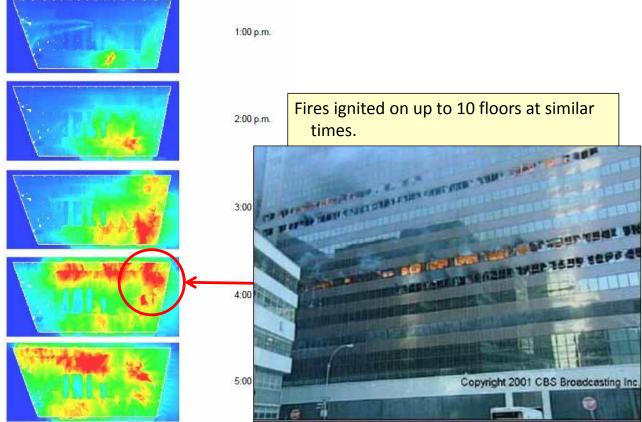
# Simulated fire progress on Floor 12

Between floors 7-14 fires were sustained but moved around the floors in different directions.

In mid-afternoon fires were observed simultaneously around the North-East corner of the building on these floors.

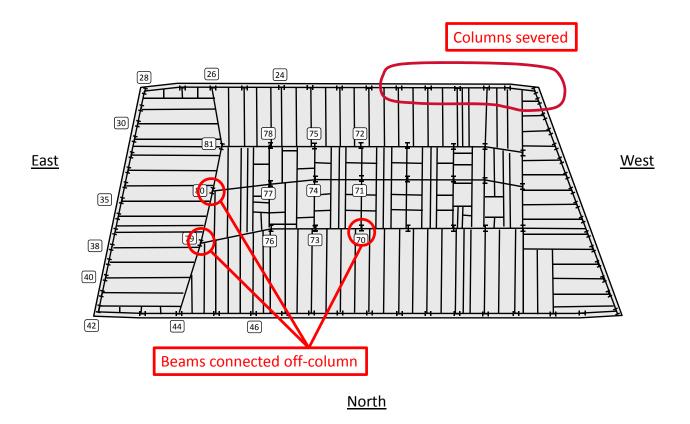
#### Typical floor beam & column layout

Composite (secondary) beams with shear studs into slab.

Girders (primary beams) are non-composite (no shear studs).

Only 3 girders connected to Column 79.

Composite beams frame into girders close to column.

Beam spans in North-East corner zone about 15m in length.

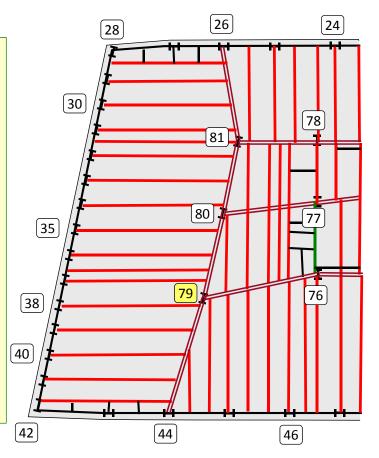
#### Heating of structure around Column 79

Fire protection on beams and columns was probably intact.

Beams probably achieved 600°C in places on Floors 8, 12, 13, 14, and 400°C in places on Floors 9, 10,

Interior columns all probably stayed below 200°C.

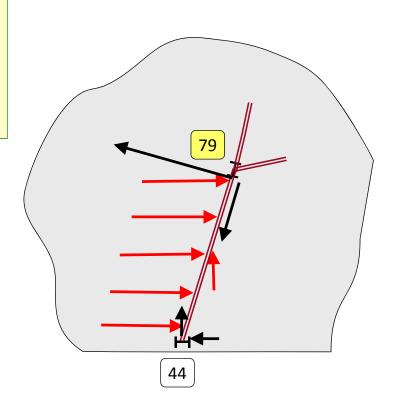
#### Floor structure around Column 79

At ~500°C a 15m composite (secondary) beam has a <u>free</u> thermal expansion of ~90mm.

If this is restrained by the noncomposite girder, it creates large transverse forces on the girder.

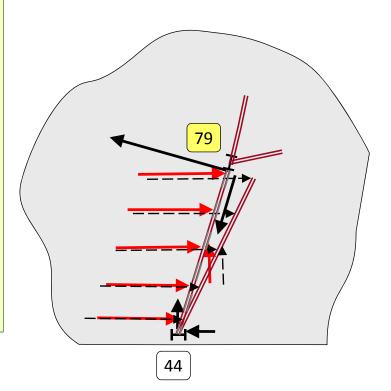
#### Floor structure around Column 79

At ~500°C a 15m composite (secondary) beam has a <u>free</u> thermal expansion of ~90mm.

If this is restrained by the noncomposite girder, it creates large transverse forces on the girder.

Bolts on seating plate and locating cleat fracture in shear (probably on Floor 13), and the girder 44-79 collapses.

This is repeated in sequence on lower floors due to impacts and similar restraint forces from simultaneous fires.

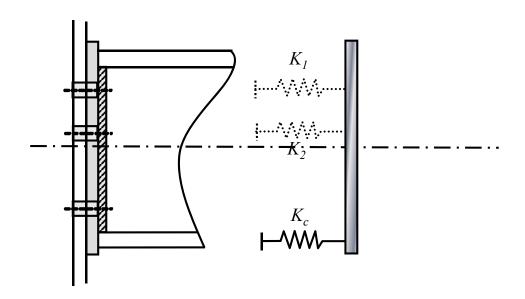
# The "Component" method with axial force

• Component model deals with load combinations automatically, though M-f curves change due to thrust.

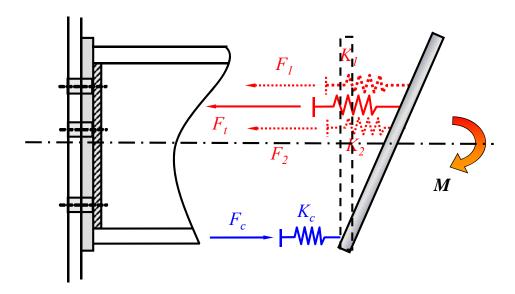
# The "Component" method with axial force

Component model deals with load combinations automatically, though M-f curves change due to thrust.

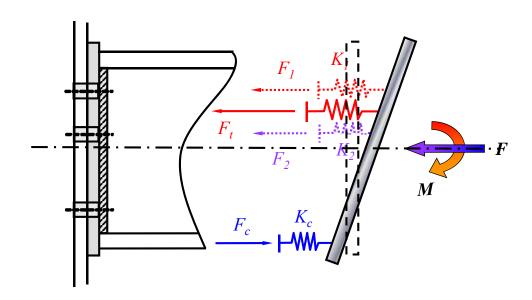
# The "Component" method with axial force

• Component model deals with load combinations automatically, though M-f curves change due to thrust.

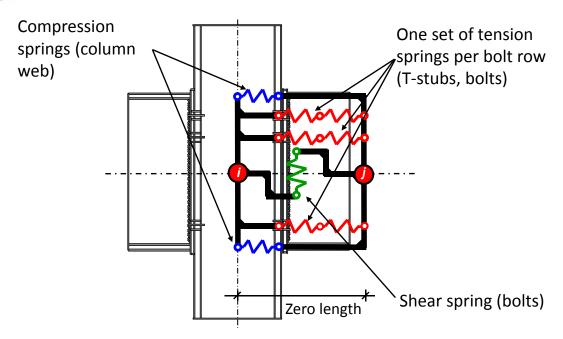
### Component-Based Connection Element (Block)

- Beam-end and centre line of column assumed to remain plane
- Tension and compression forces have different lines of action
- Only depends on the geometry and the material of the connection
